## NEWBERRY & ASSOC. MARINE SURVEYING CO.

File #D2151001R

#### AMENDED DAMAGE REPORT

Donzi ZSF (38' Center Console Cuddy Cabin

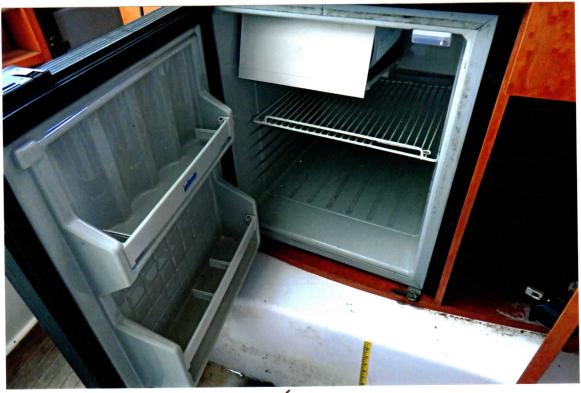
- 1) Found: The Isotherm model 1006520 12/24 volt under counter refrigerator submerged in rainwater. See photos 5-6.

Recommend: Renew refrigerator as original.
- 2) Found: Laminated plywood under counter galley module with pantry doors and drawers water damaged and delaminated beyond repair. See photos 5-6.

Recommend: Renew galley pantry module as original.

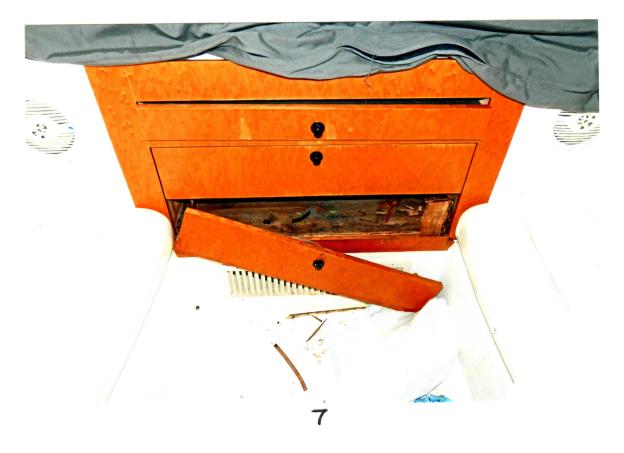
3) Found: Laminated plywood V-berth three drawer module water damaged and delaminated beyond repair. See photos 7.

Recommend: Renew drawer module as original.

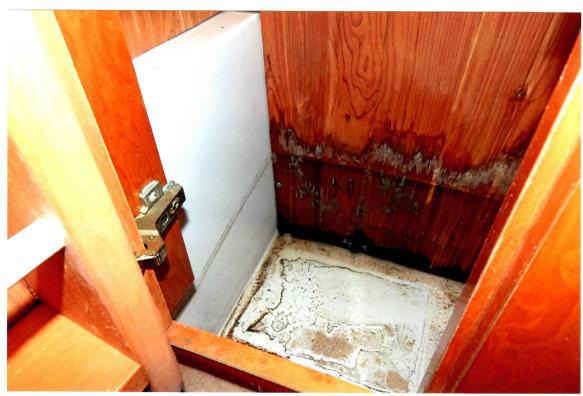
4) Found: Laminated plywood hanging locker module aft of galley water damaged and delaminated beyond repair. See photos 8.

Recommend: Renew hanging locker module as original.

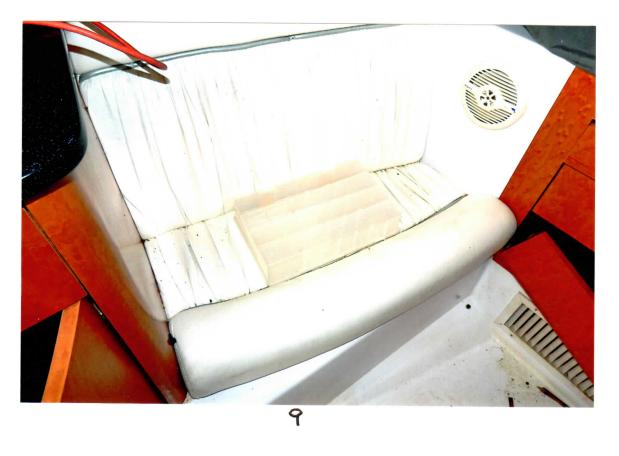
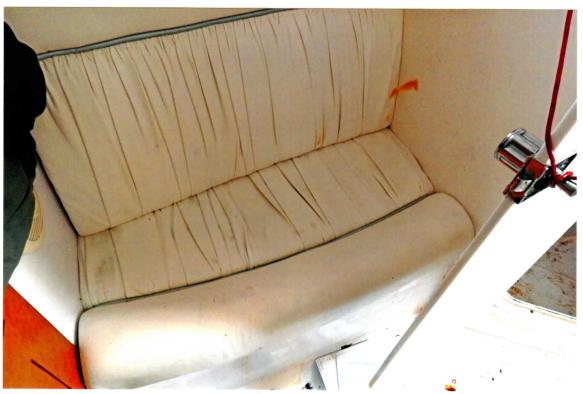
5) Found: Port and starboard settee cushions were submerged in rain water. See photos 9-10.

Recommend: Renew settee cushions as original.

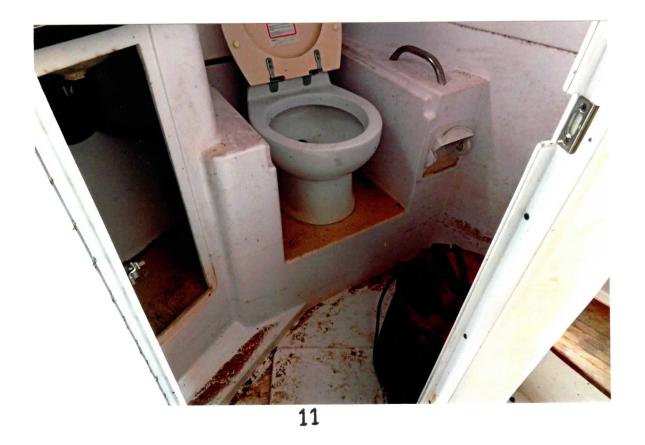
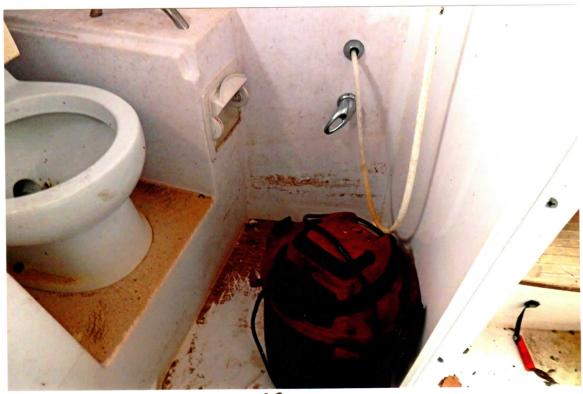
6) Found: Head and fiberglass module had been submerged in rainwater. See photos 11-12.

Recommend: Clean head module as needed.

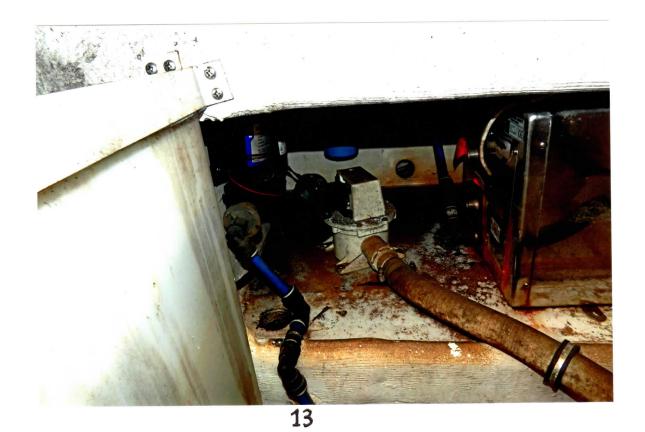
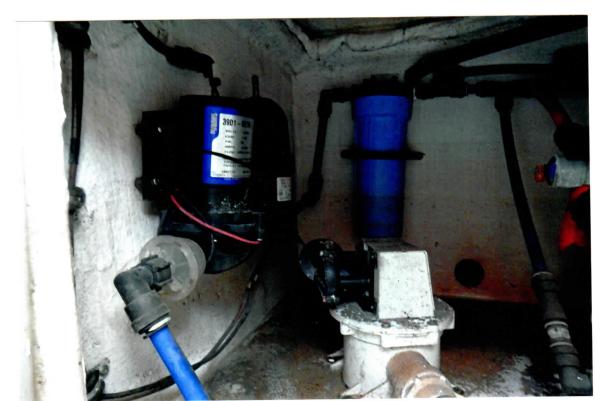
7) Found: 120 volt stainless steel water heater, 12 volt fresh water pressure pump, head vacuum pump, plastic accumulator tank water filter, plumbing and wiring submerged in rainwater. See photos 13-14.

Recommend: Renew water heater, electric pumps and wiring, clean filter, accumulator tank, plumbing, renew hose clamps as needed as original.

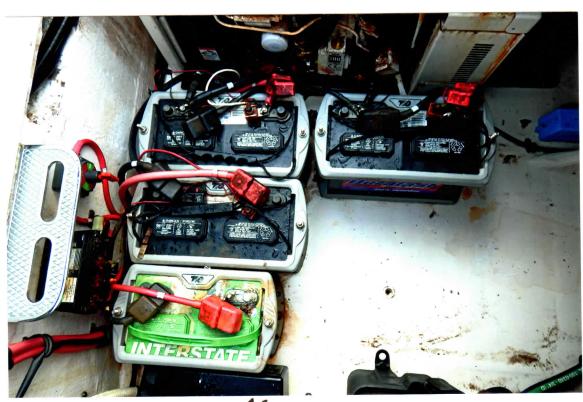
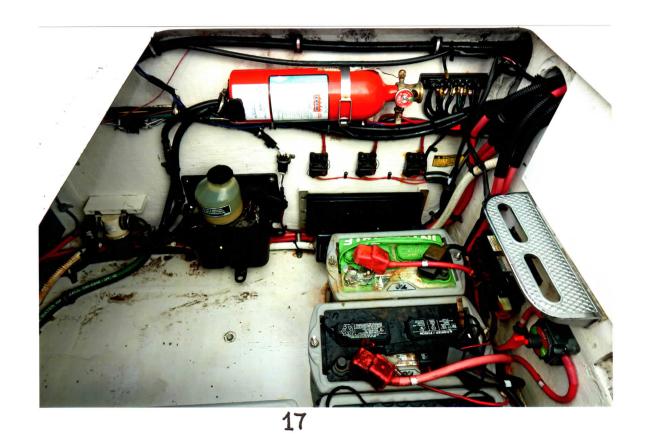
9) Found: All four ships lead acid batteries (3 gp29 and 1 gp24), battery wiring, selector switches, breakers and terminals submerged in rainwater. See photos 16-17.

Recommend: Renew all batteries, associated wiring and switches as original.

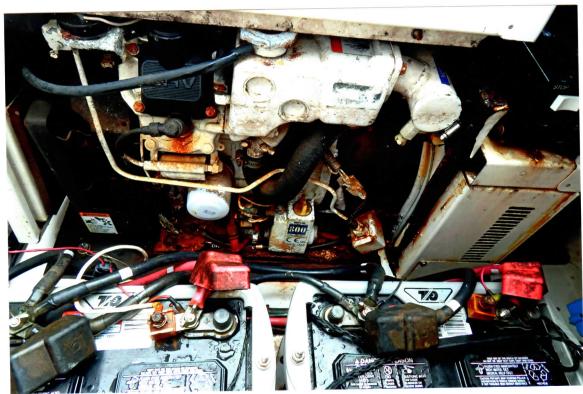
10) Found: Kohler Marine generator model # submerged in rainwater and damaged beyond repair. See photos 18.

Recommend: Renew generator, associated wiring and switches as original.

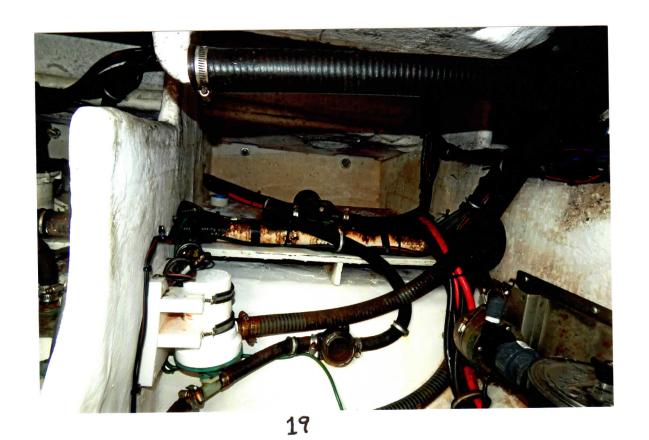
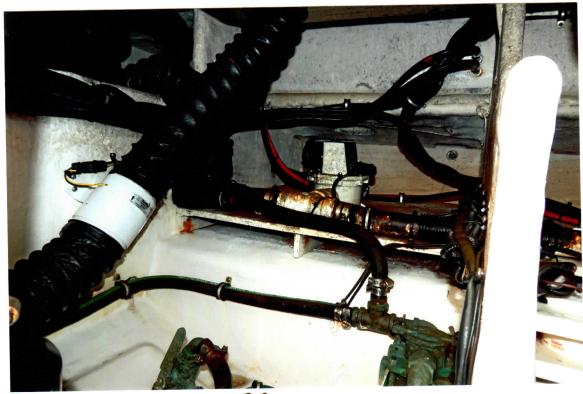
11) Found: 12 volt sea-water deck wash-down pump, holding tank 12 volt macerator pump, 12 volt bilge blower, plumbing, hose clamps, 12 volt and 120 volt wiring in machinery space submerged in rainwater. See photos 19-20.

Recommend: Renew deck wash-down pump, macerator pump, bilge blower, plumbing, hose clamps, 12 volt and 120 volt wiring as original.
